Promise of stainless steel undermined

There is a rising trend towards carbon steel fabricators moving into the stainless steel area without a proper understanding of the differences. This article explains how the South African Stainless Steel Development Association (sassda) is fighting to uphold industry standards and be a voice for best practice.

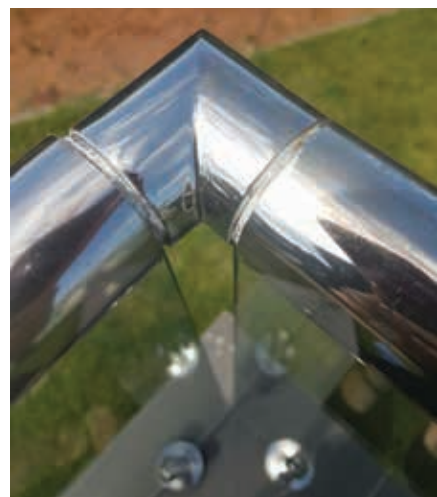
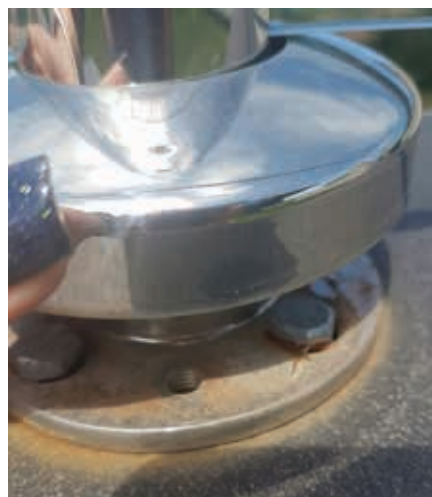
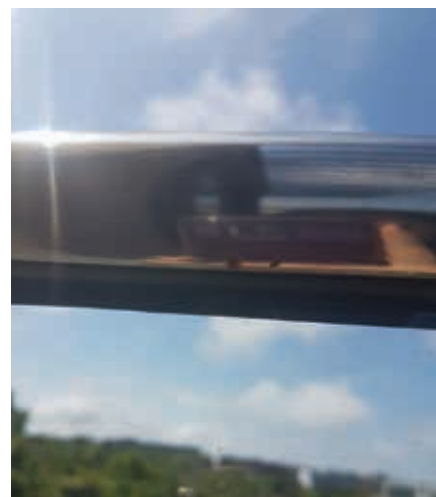
Examples of sub-standard stainless steel balustrade installation in KwaZulu-Natal.

"It was completely unacceptable that carbon steel bolts had been used, which accelerate galvanic corrosion and would cause the balustrade to fail in a relatively short period, leading to a possible safety hazard. The balustrade materials had also been contaminated by carbon steel carry-over in places, either during fabrication or installation, resulting in premature staining of the base material. Joints in the balustrade had been glued with an epoxy or adhesive instead of being welded and had come loose, with further poor joint quality seen in its construction, and the stainless steel had not

been correctly polished after installation.

"The job clearly did not comply with the legal requirements of SANS 10400 or SANS 10160, both of which require approval of the design and installation by a suitably qualified professional engineer, which we doubt was done. Quite bluntly, the balustrade was a hazard and dangerous to the safety of the homeowner. We advised that the entire structure be removed, at the fabricator's cost, and replaced using an experienced balustrade manufacturer," says Baker.
