Multotec's wear and risk warning systems

Early warning systems across a range of Multotec's wear solutions - built in as standard and at no added expense – are important aspects of the group's efforts to save customers from the high cost of unexpected failure.

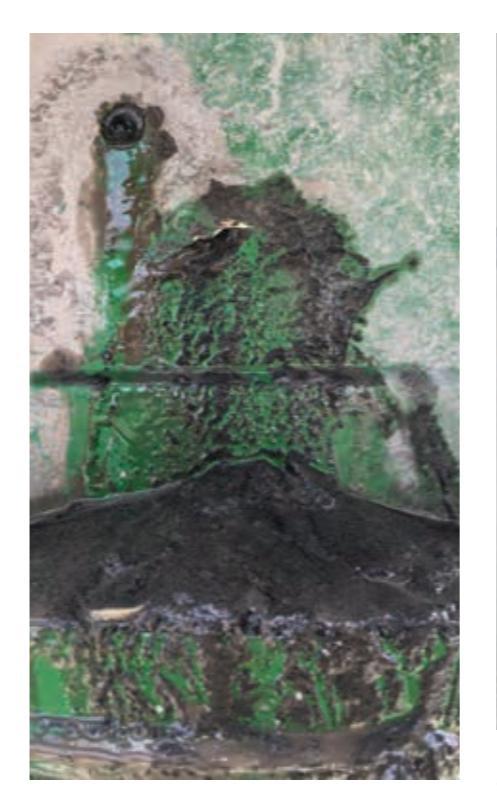
The weep hole allows inspection of the cyclone to be done while it is in operation.

Group company Multotec Process Equipment supplies a wide variety of cyclones, among them the HC cyclone range, which comprises a mild steel outer shell and an inner, wear surface of thick, loose rubber lining. "The key design feature for early warning of wear is a 'weep hole' in the mild steel shell," Taylor explains. "If the rubber lining wears through or is severely damaged by a large or sharp particle, the slurry will leak between the lining and the shell and escape from the cyclone through the weep hole - which is filled only with a loose plastic insert. The internal surface of the plastic inserts prevents the liner from blocking the weep hole."

Being alerted to the lining failure by slurry on the plant floor removes the risk of the steel case being irretrievably damaged while not protected by the lining, which would lead to the expensive and time-consuming process of changing the cyclone body.

The advantage of the weep hole is also that the inspection of the cyclone can be done while it is in operation. As soon as a problem is identified, the cyclone can simply be removed from the circuit and, if possible, substituted while the loose liner is replaced. This also means that the maximum lifespan of the liner can be extracted, helping reduce operating costs.

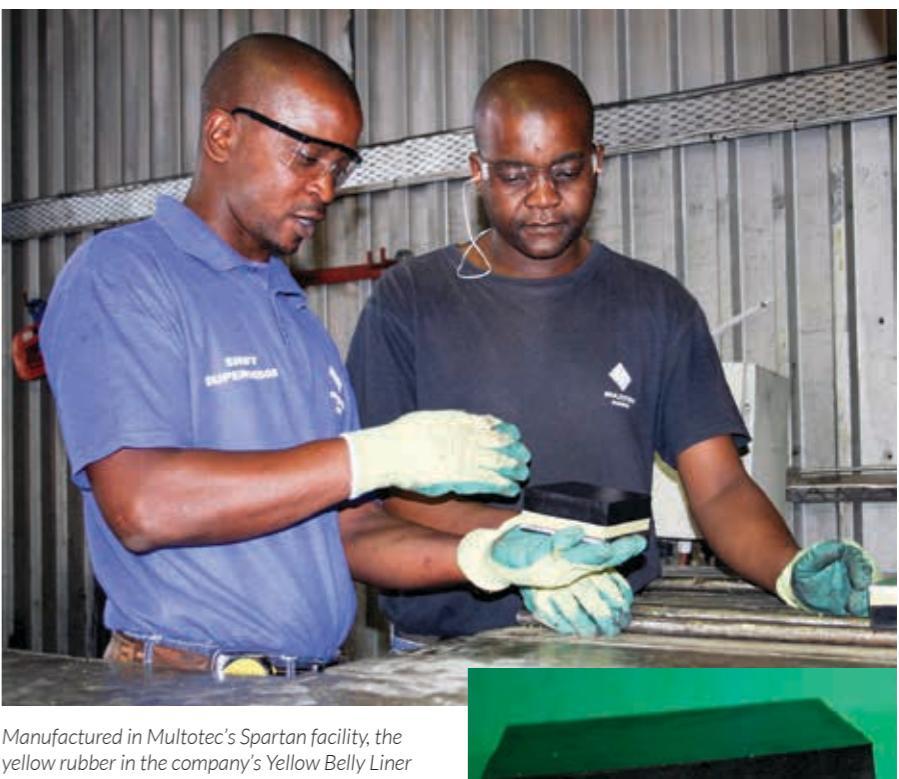
is the same high quality as the Multotec black rubber installed in high-impact and high-abrasion applications.

To combat wear in ore transfer chutes and similar applications, Multotec Rubber supplies rubber wear plates that now also come in 'Yellow Belly' format.

"Our recent innovation with these products has been to colour the layer of rubber immediately above the steel backing plate a bright yellow, hence the name," says Taylor. "When the wear on the rubber plate reaches the level of the yellow rubber, the colour is easily visible during inspections; this indicates that there is still some life left in the plate but that replacement must be conducted in the near future to avoid damage to the backing plate."

He emphasises that the yellow rubber is the same good quality as the black rubber that Multotec has installed in high-impact and high-abrasion applications throughout Africa. So the remaining wear, after the yellow colour is first exposed, gives the plant operators time to decide whether they want to replace the plate immediately or address it during an imminent, scheduled process plant shutdown.

Multotec's rubber wear plates range in size up to 1260×1320 mm and 1000×2000 mm, which can be cut to suit the liner configuration. They are available in a thickness from

40 mm to 200 mm including the steel backing plate, which measures from 3.0 mm to 10 mm thick, depending on the rubber thickness and the application.
