# Skyriders puts an eye in the sky

Industrial rope access company, Skyriders, has brought cost and time saving solutions to the company and its clients by introducing collision resistant drone technology to access areas that may pose health, safety and environmental risks on large industrial projects. Mike Zinn talks to *MechChem Africa*.

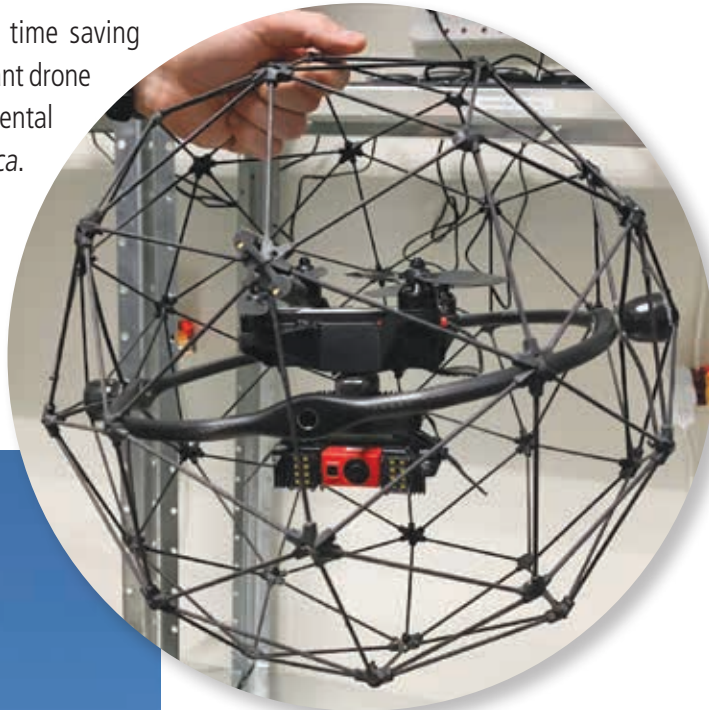
*Skyriders Elios Sky Eye technology is the world's first collision-tolerant drone that can access controlled and confined spaces without any risk of crashing.*

The Skyriders Elios Sky Eye drone is the world's first collision-tolerant drone that can access controlled and confined spaces without risk of crashing. It also avoids expensive time-consuming access methods such as scaffolding, says Zinn.

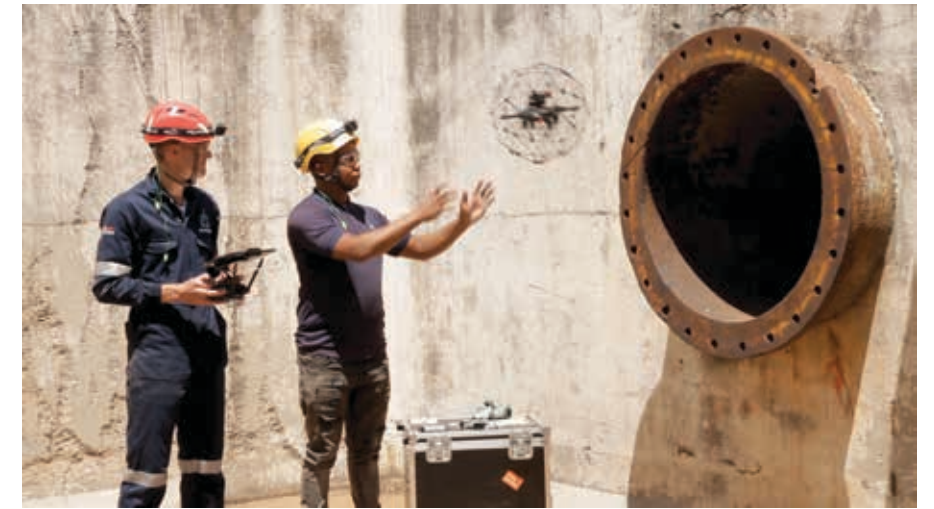
*This was the first time the system was used in conjunction with UT wall-thickness inspection.*

"This is where the expertise and technology of Skyriders was called upon. While the client has previously used Skyriders Elios Sky Eye technology for inspection purposes, this was the first time the system was used in conjunction with rope access aided UT wall-thickness inspection," says Zinn.

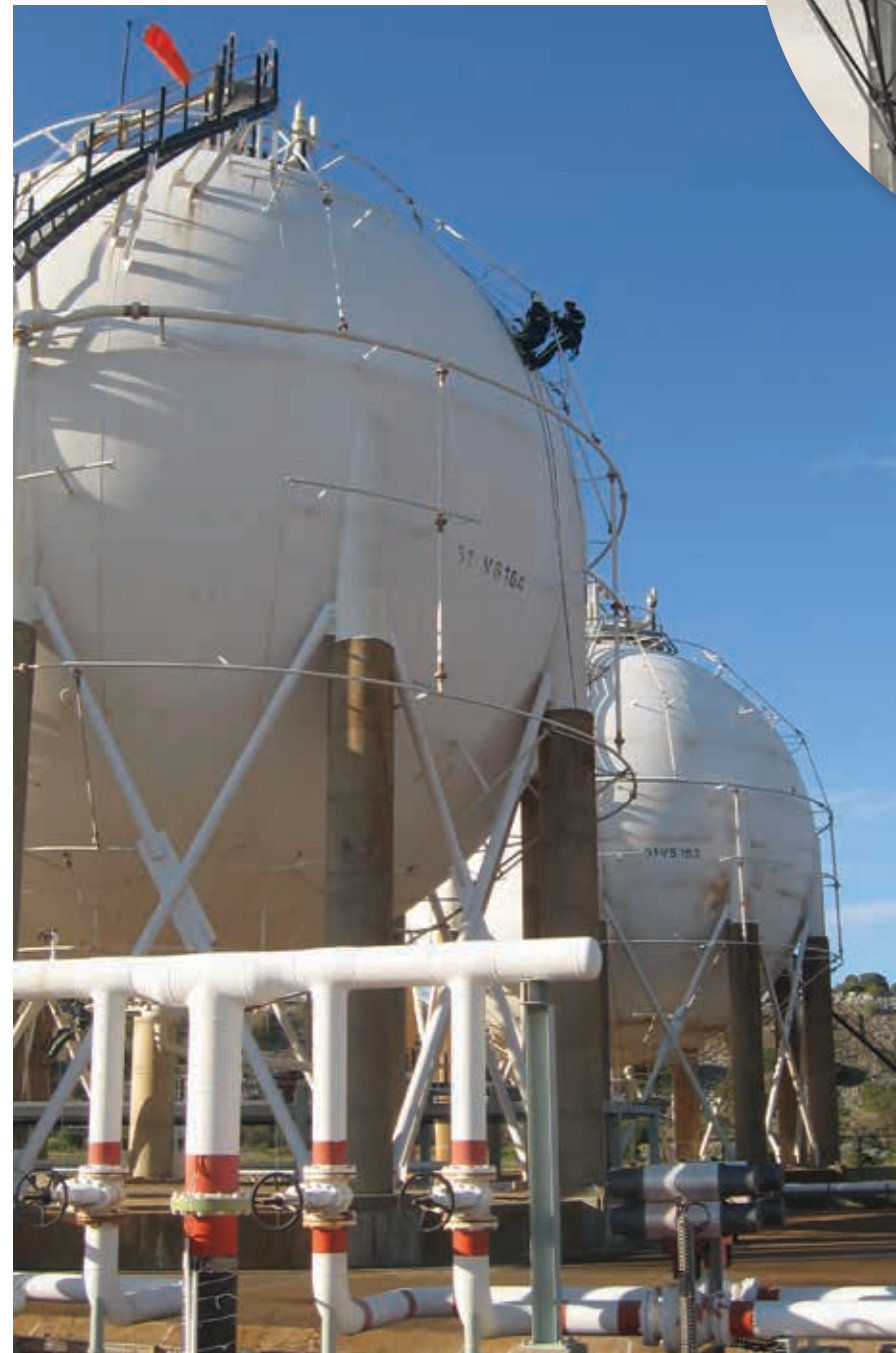
*Technicians used rope access to reach the 14 m high roof and carried out UT wall-thickness measurement on select steel members.*

ceived the necessary permit in this regard. The drone was used to conduct a thorough visual inspection of the internal support structure to see if it was safe – that there was no bending or buckling. Thereafter, technicians used rope access to reach the 14 m high roof, and carried out UT wall-thickness measurement on select steel members.
